CAPITAL IMPROVEMENT PROGRAM
City of Missoula CIP Project Request Form FY 2014-2018

Program Category:	Project Title:		12 Project #	13 Project #	14 Project #
Community Service	Grant Creek Drainage Improvements		CS-08	CS-08	CS-08

RE: Grant Creek Between I-90 and Prospect Drive

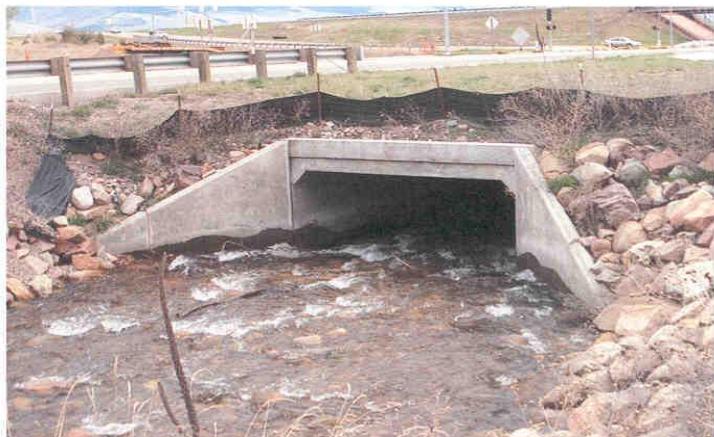
#1

My first concern is with the debris collecting on the bottom of the box culvert or being moved into the box culvert during high water. I doubt if anyone regularly inspects the interior of the culvert. Unlike most culverts, the irregular bottom is ideal for trapping debris. If a blockage took place during any significant event, no one could clear it by entering either end for fear of drowning. Flood flows would then crest and flow under I-90 and down Reserve Street. Grant Creek is rated at 245 CFS for a 10 year, 380 CFS for a 50 year, 465 CFS for a 100 year and 730 CFS for a 500 year storm event. These are significant flows and they will move accumulated debris downstream to the box culvert.

**North end of
800-foot long
(14'x7') box culvert
under I-90 and
Reserve Street
intersection**

I would advise that serious consideration be given to clearing the floodway of accumulated debris, thinning brush, and thickets in the floodway and along Grant Creek Road to provide a safe and healthy riparian area and roadway. I also advise that the box culvert be inspected and a debris trap be constructed upstream of the box culvert.

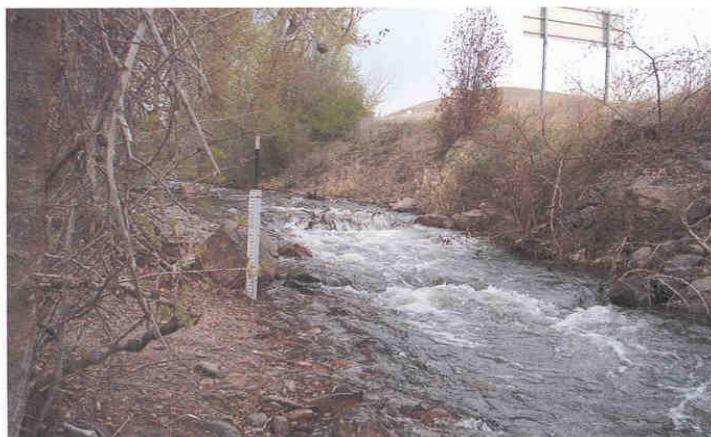
#2

**Stream gauging
station between I-90
and Expo Parkway**

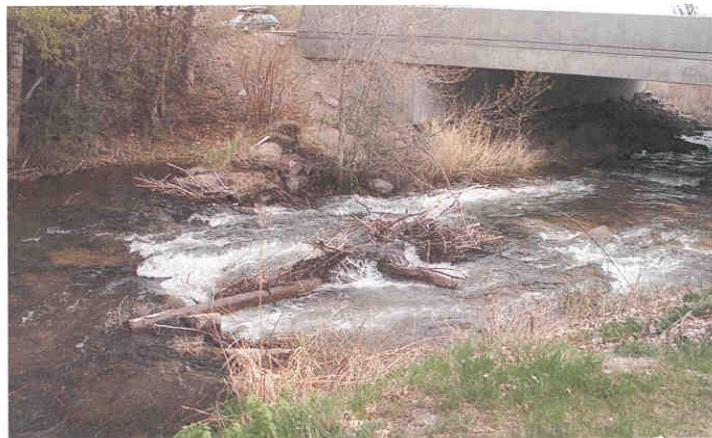
#3

My second concern is with the upstream channel blockages by fallen trees and debris accumulation in the flood way. Trees that have fallen across and into the channel creating barbs that direct flows against the side of the channel and possibly the levee or Grant Creek Road. During a major event, the accumulated debris will collect on fallen trees creating dams that will raise the 100-year flood profile, placing adjacent property and improvements at risk. If water ever exited the west side of Grant Creek, it would not have a chance to get back into the channel before it discharged under I-90 and down Reserve Street.

**Logs and debris
upstream of Expo
Parkway**
